**UNITED STATES AIR FORCE  
JOINT BASE ELMENDORF-RICHARDSON,  
ALASKA**

*ENVIRONMENTAL RESTORATION PROGRAM*

**FOURTH CERCLA FIVE-YEAR REVIEW  
REPORT**

**JBER-ELMENDORF, ALASKA**

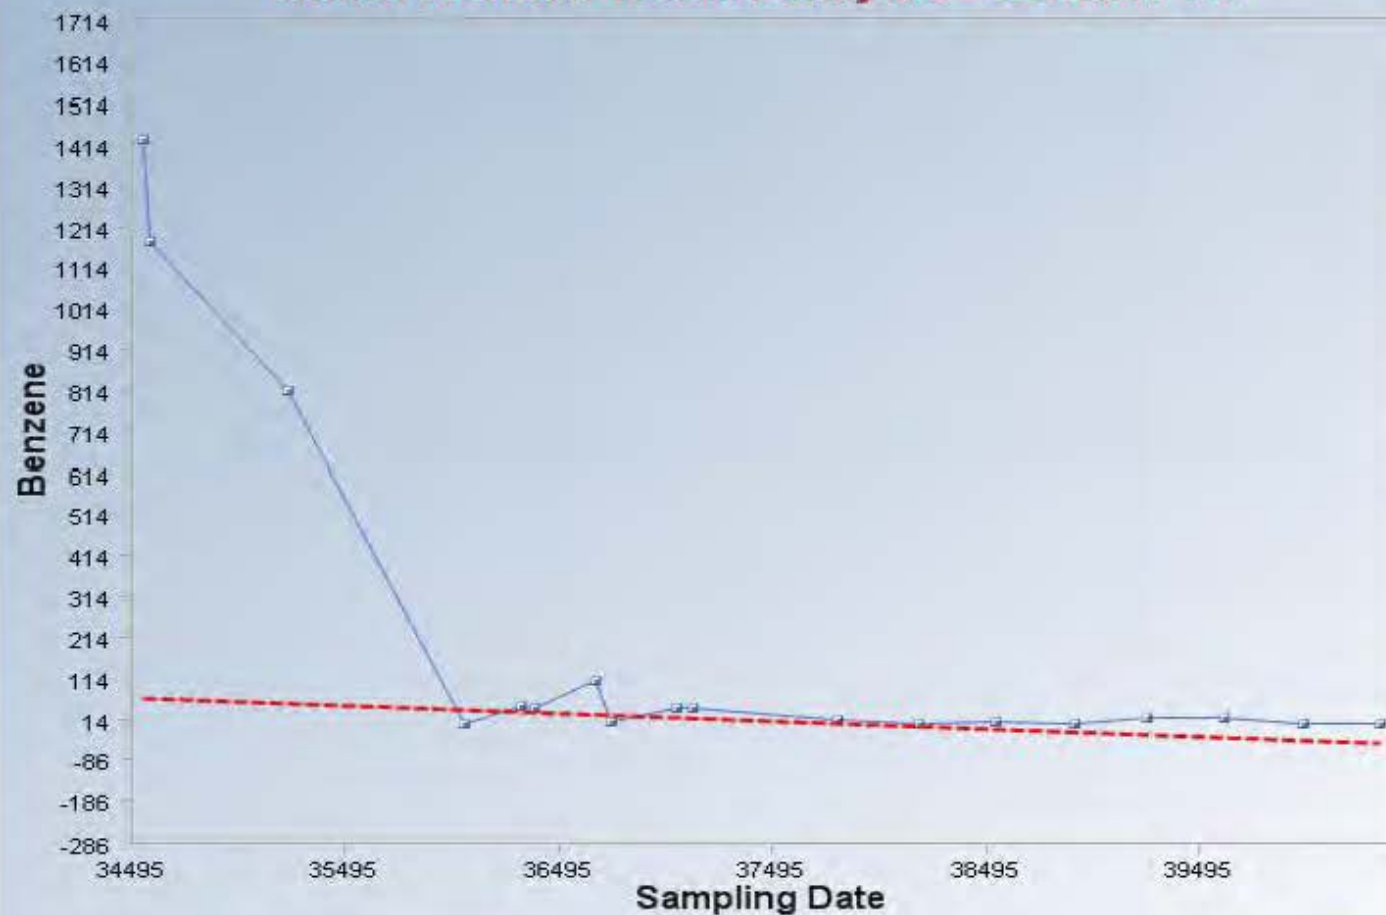
## Mann-Kendall Trend Analysis - OU6MW-18

### Mann-Kendall Trend Analysis

n	18.0000
Confidence Coefficient	0.9500
Level of Significance	0.0500
Test Value (S)	-82
Tabulated p-value	0.0010
Standard Deviation of S	26.3818
Standardized Value of S	-3.0703
Approximate p-value	0.0011

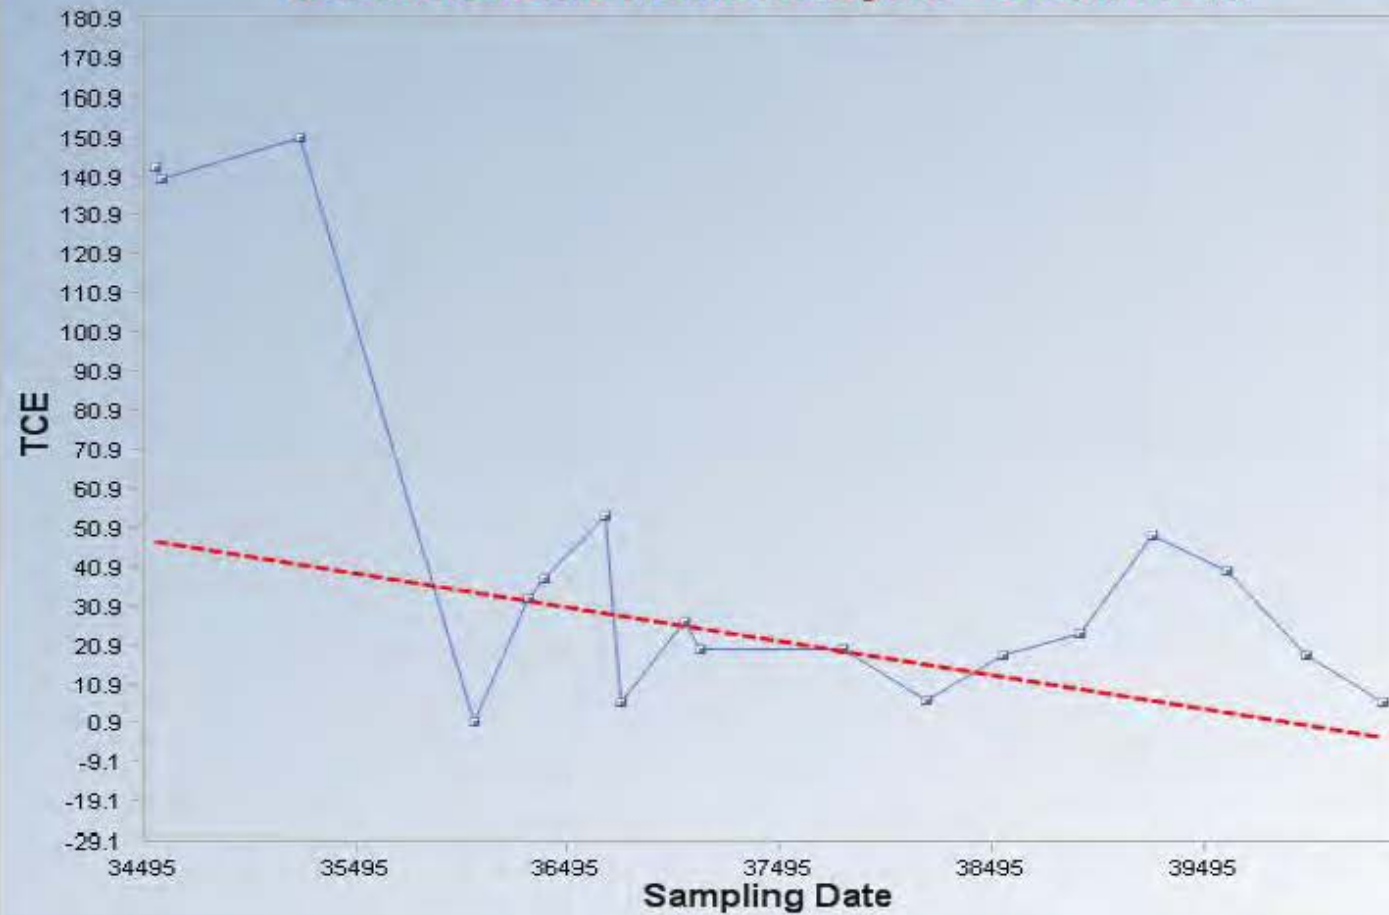
## Mann-Kendall Trend Analysis - OU6MW-18

### Mann-Kendall Trend Analysis

n	18.0000
Confidence Coefficient	0.9500
Level of Significance	0.0500
Test Value (S)	-51
Tabulated p-value	0.0290
Standard Deviation of S	26.3629
Standardized Value of S	-1.8966
Approximate p-value	0.0289

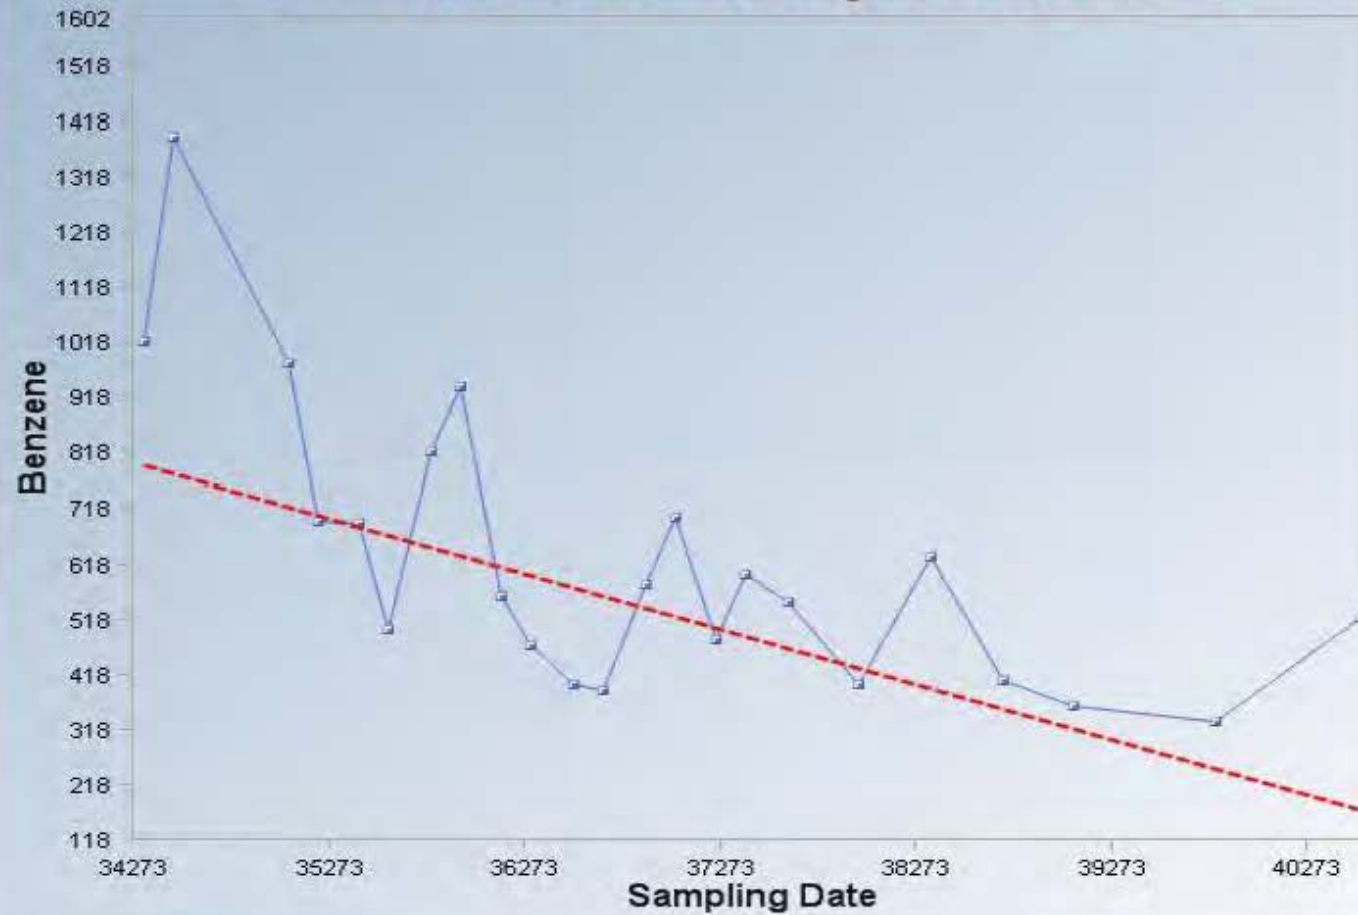
## Mann-Kendall Trend Analysis - OU6MW-46

### Mann-Kendall Trend Analysis

n	23.0000
Confidence Coefficient	0.9500
Level of Significance	0.0500
Test Value (S)	-132
Critical Value (0.05)	-1.6449
Standard Deviation of S	37.8506
Standardized Value of S	-3.4610
Approximate p-value	0.0003

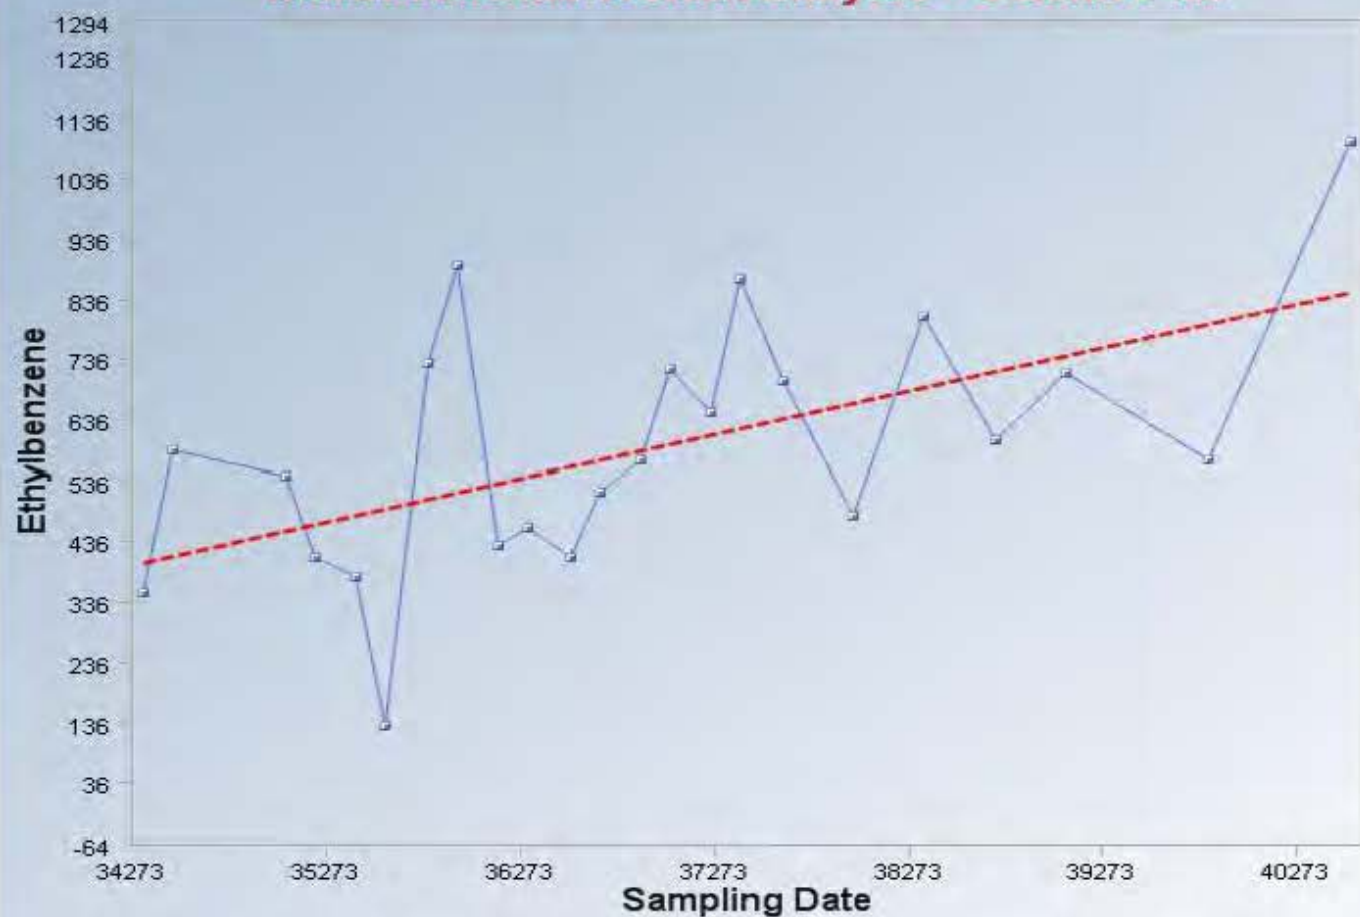
## Mann-Kendall Trend Analysis - OU6MW-46

### Mann-Kendall Trend Analysis

n	23.0000
Confidence Coefficient	0.9500
Level of Significance	0.0500
Test Value (S)	99
Critical Value (0.05)	1.6449
Standard Deviation of S	37.8374
Standardized Value of S	2.5900
Approximate p-value	0.0048

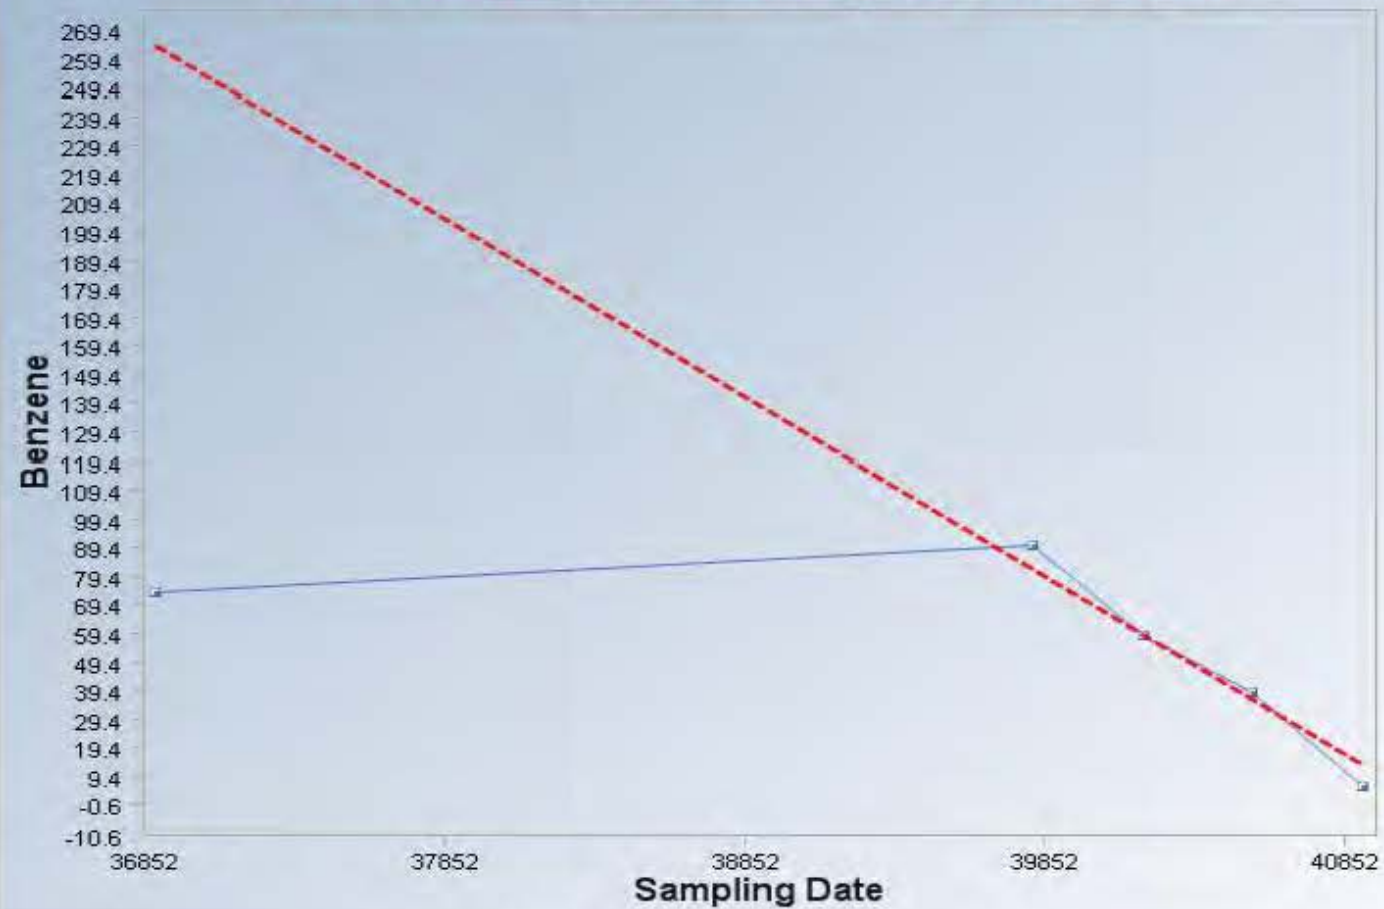
## Mann-Kendall Trend Analysis - OU6MW-92

### Mann-Kendall Trend Analysis

n	5.0000
Confidence Coefficient	0.9500
Level of Significance	0.0500
Test Value (S)	-8
Tabulated p-value	0.0420
Standard Deviation of S	4.0825
Standardized Value of S	-1.7146
Approximate p-value	0.0432

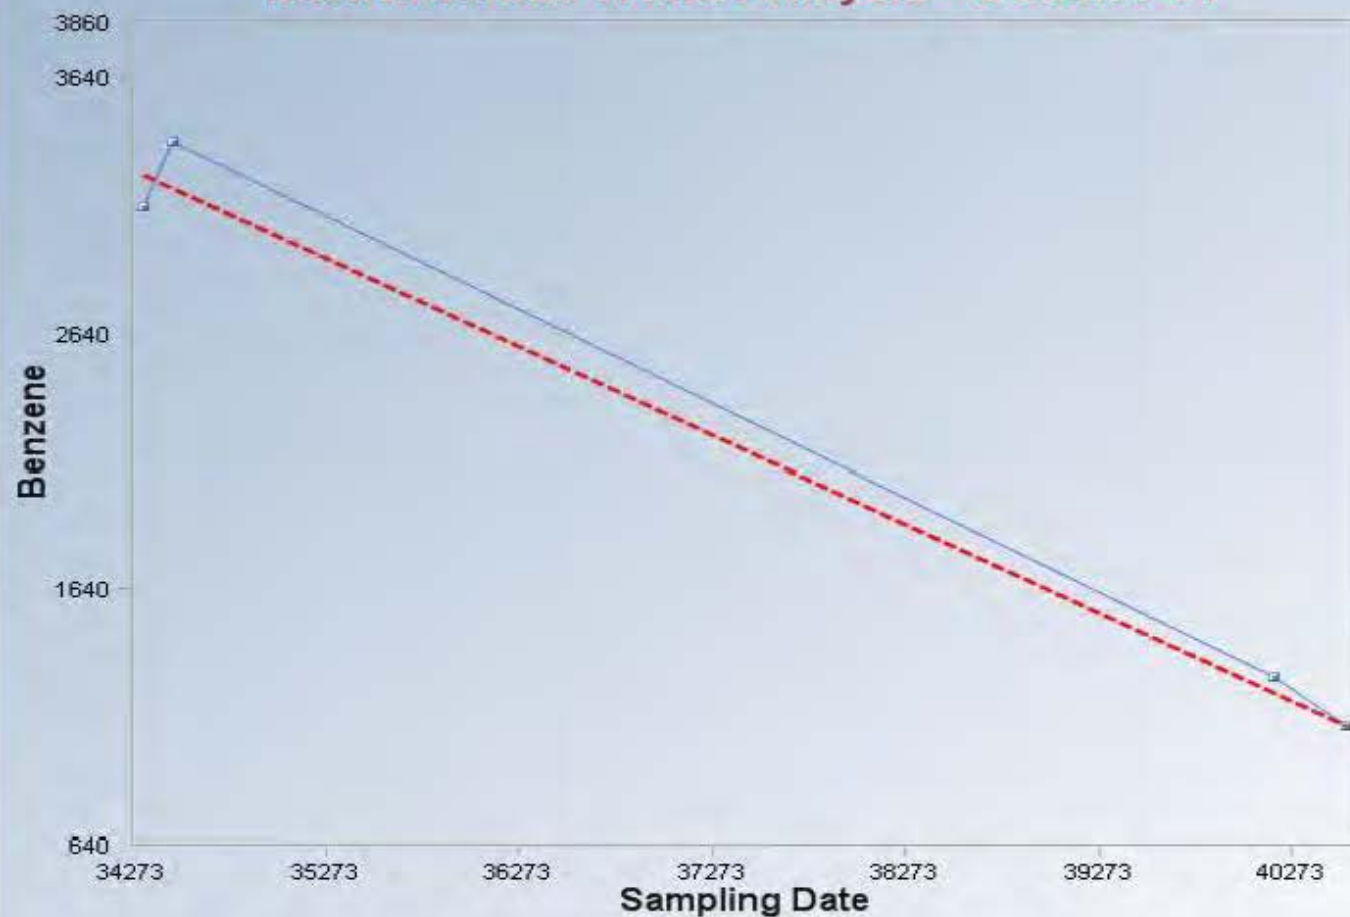
## Mann-Kendall Trend Analysis - OU6MW-61

### Mann-Kendall Trend Analysis

n	4.0000
Confidence Coefficient	0.9500
Level of Significance	0.0500
Test Value (S)	-4
Tabulated p-value	0.1670
Standard Deviation of S	2.9439
Standardized Value of S	-1.0190
Approximate p-value	0.1541

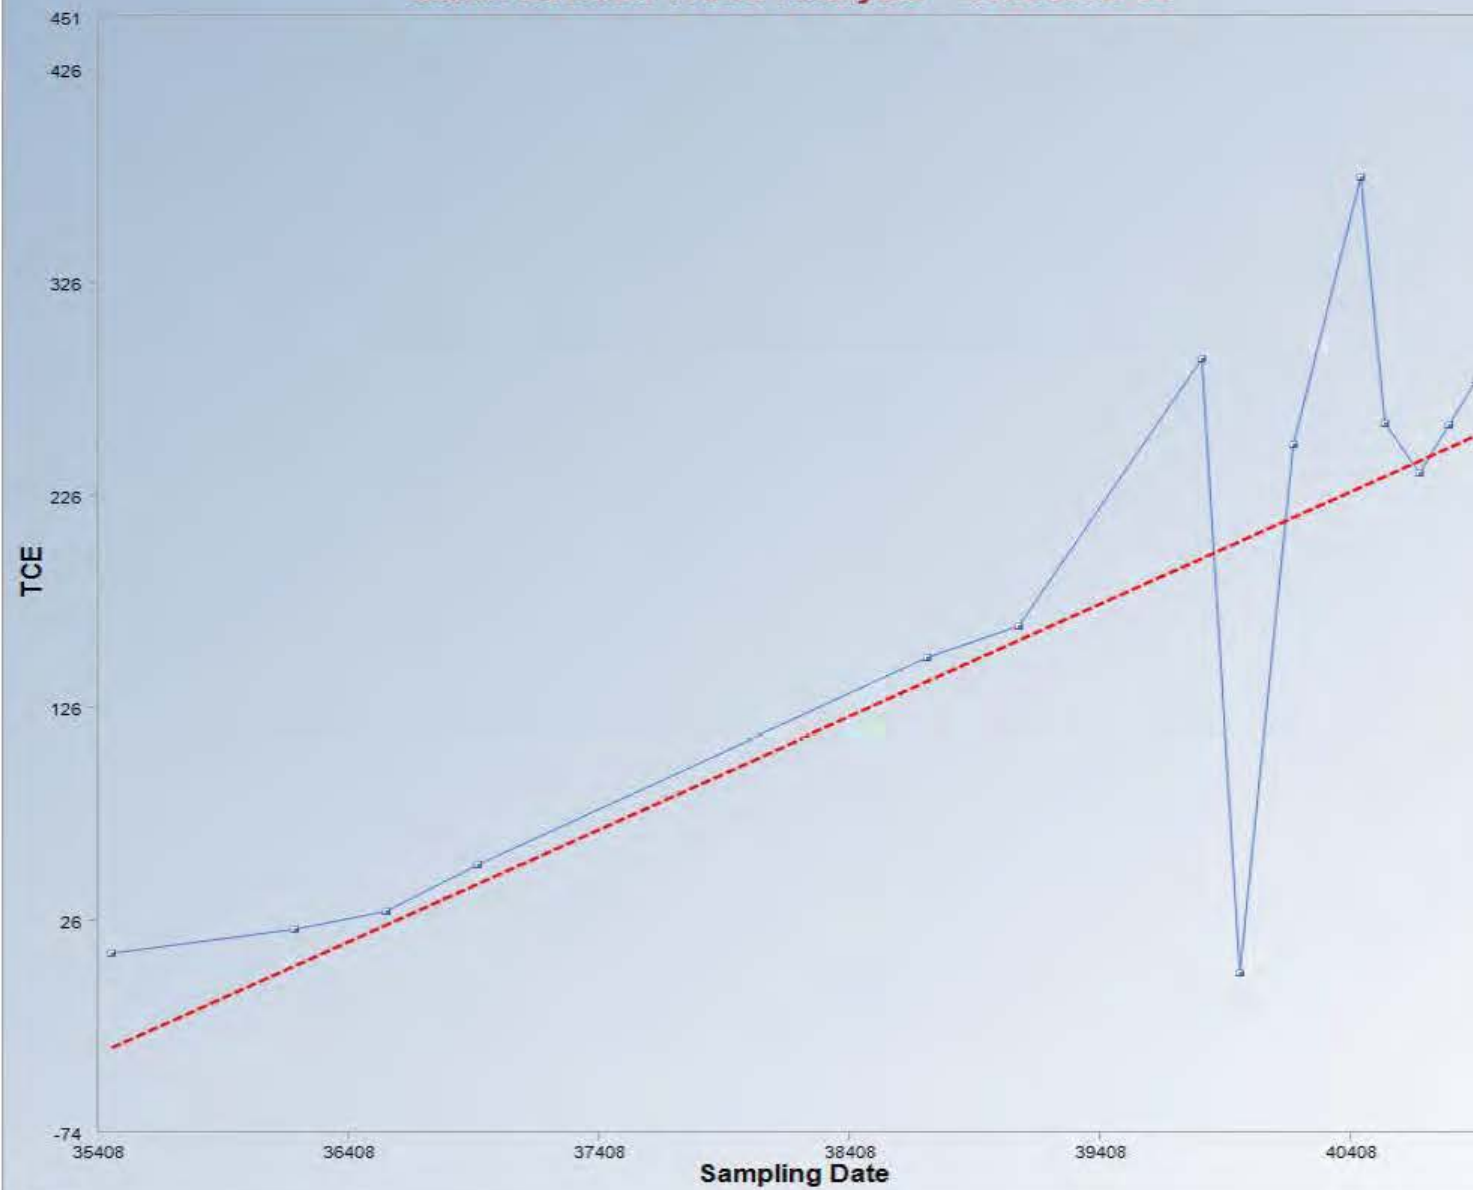
### Mann-Kendall Trend Analysis - 41755WL-08

#### Mann-Kendall Trend Analysis

n	14.0000
Confidence Coefficient	0.9500
Level of Significance	0.0500
Test Value (S)	53
Tabulated p-value	0.0020
Standard Deviation of S	18.2665
Standardized Value of S	2.8467
Approximate p-value	0.0022

Statistically significant evidence of an increasing trend at the specified level of significance.

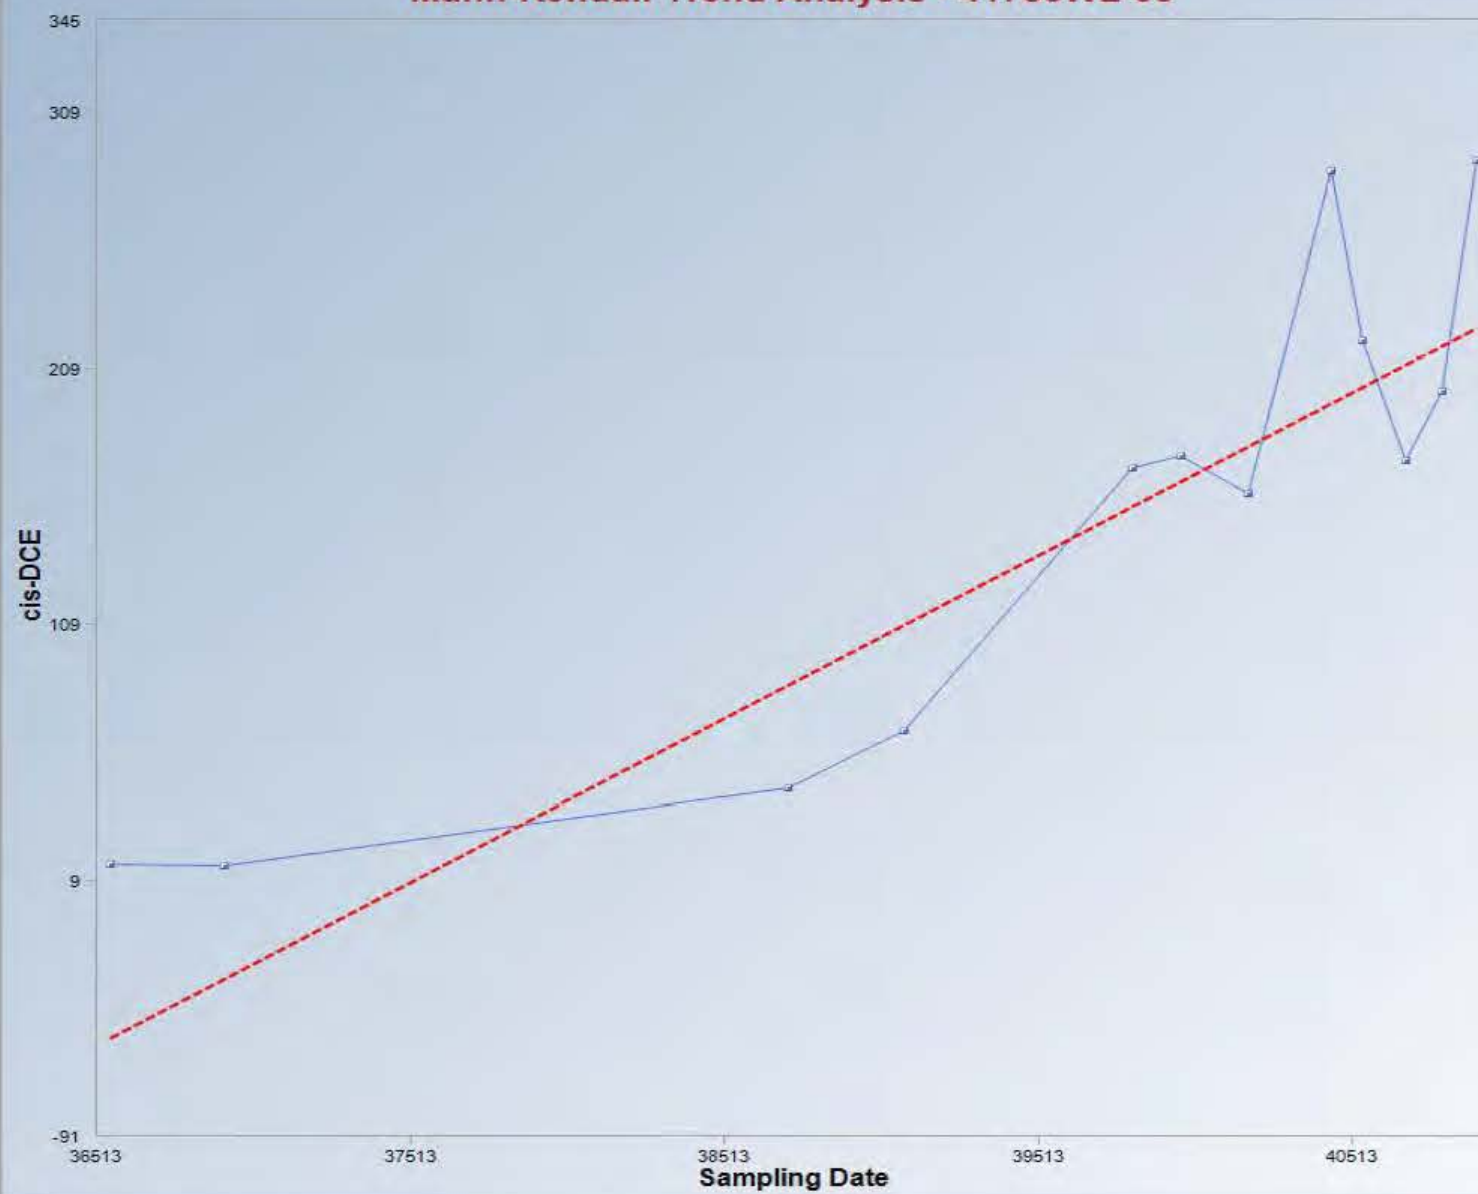
# Mann-Kendall Trend Analysis - 41755WL-08

## Mann-Kendall Trend Analysis

n	12.0000
Confidence Coefficient	0.9500
Level of Significance	0.0500
Test Value (S)	48
Tabulated p-value	0.0000
Standard Deviation of S	14.5831
Standardized Value of S	3.2229
Approximate p-value	0.0006

Statistically significant evidence of an increasing trend at the specified level of significance.

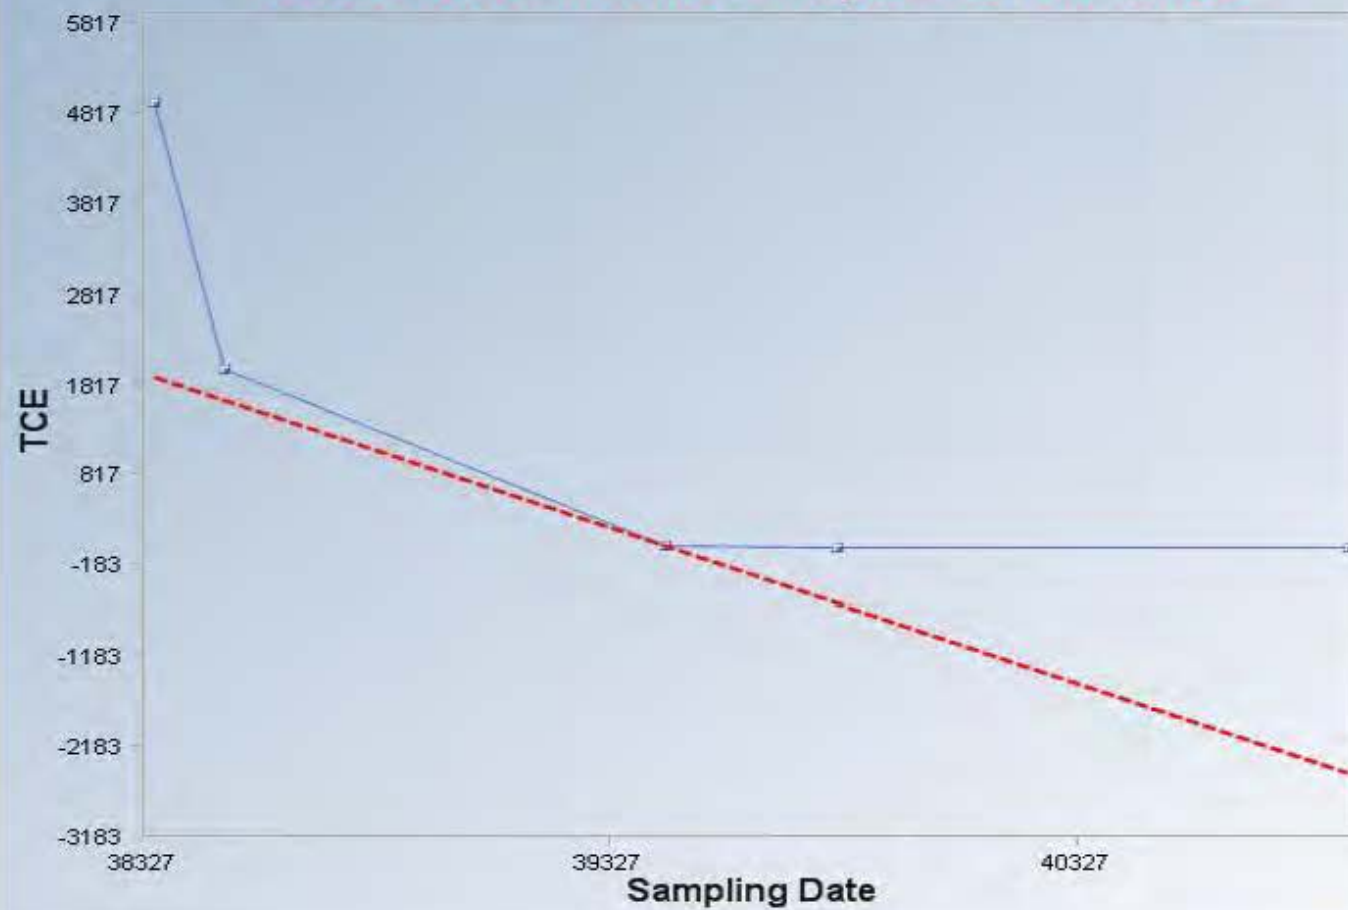
## Mann-Kendall Trend Analysis - DP98INJ-02

### Mann-Kendall Trend Analysis

n	5.0000
Confidence Coefficient	0.9500
Level of Significance	0.0500
Test Value (S)	-8
Tabulated p-value	0.0420
Standard Deviation of S	4.0825
Standardized Value of S	-1.7146
Approximate p-value	0.0432

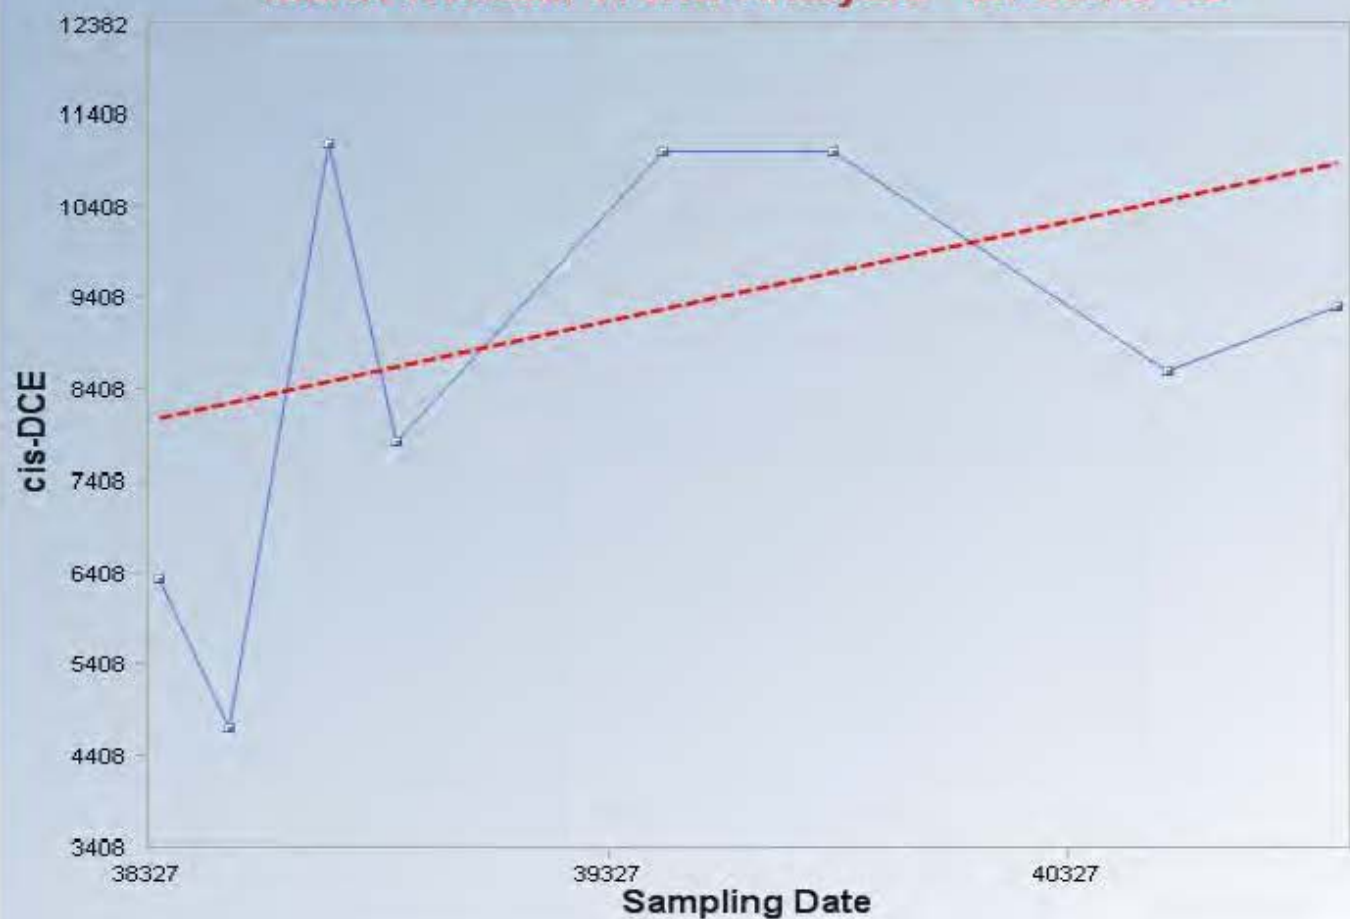
## Mann-Kendall Trend Analysis - DP98INJ-02

### Mann-Kendall Trend Analysis

n	8.0000
Confidence Coefficient	0.9500
Level of Significance	0.0500
Test Value (S)	7
Tabulated p-value	0.2740
Standard Deviation of S	8.0208
Standardized Value of S	0.7481
Approximate p-value	0.2272

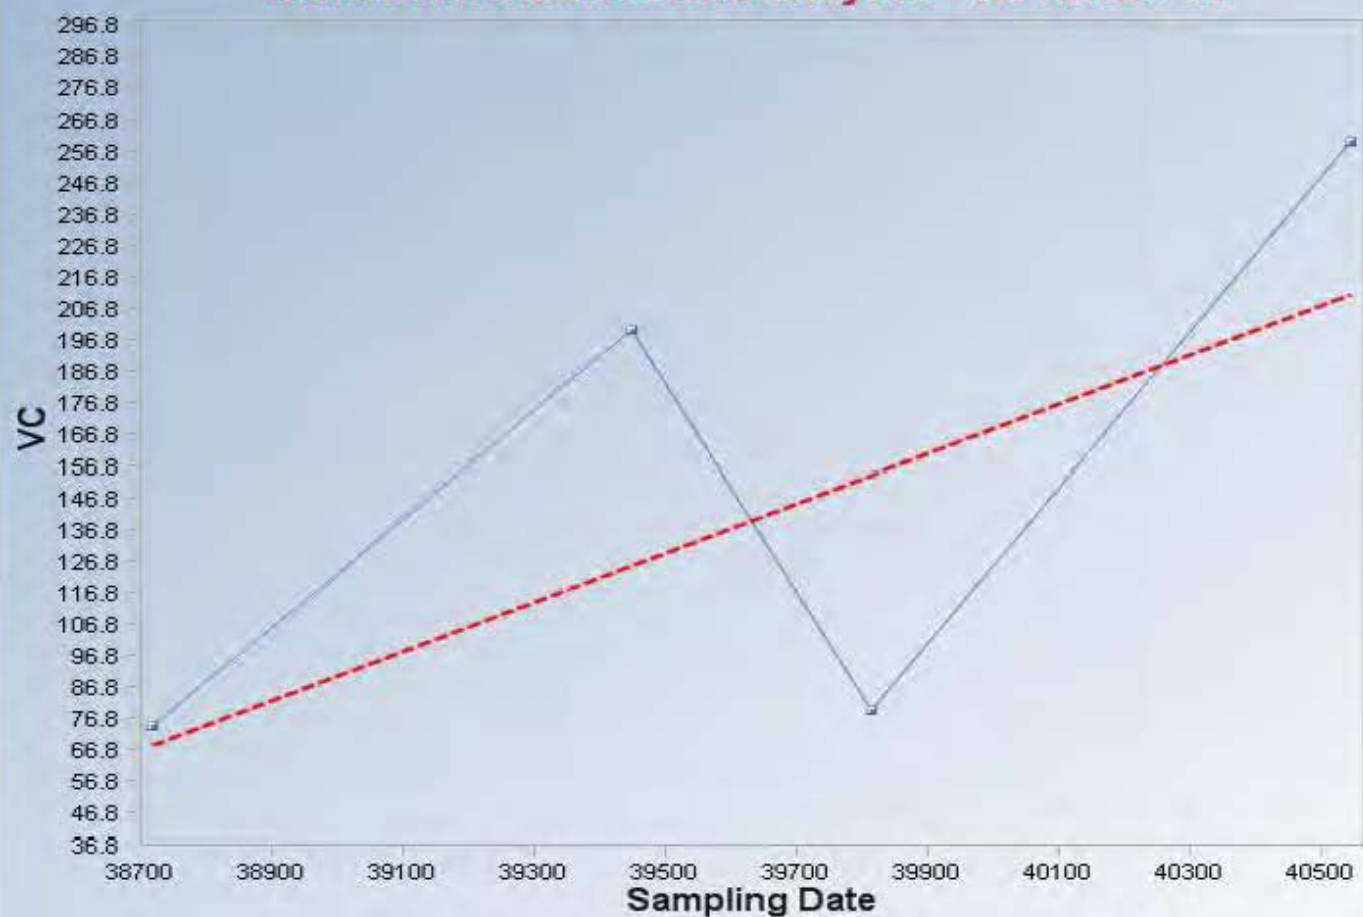
## Mann-Kendall Trend Analysis - DP98INJ-02

### Mann-Kendall Trend Analysis

n	4.0000
Confidence Coefficient	0.9500
Level of Significance	0.0500
Test Value (S)	4
Tabulated p-value	0.1670
Standard Deviation of S	2.9439
Standardized Value of S	1.0190
Approximate p-value	0.1541

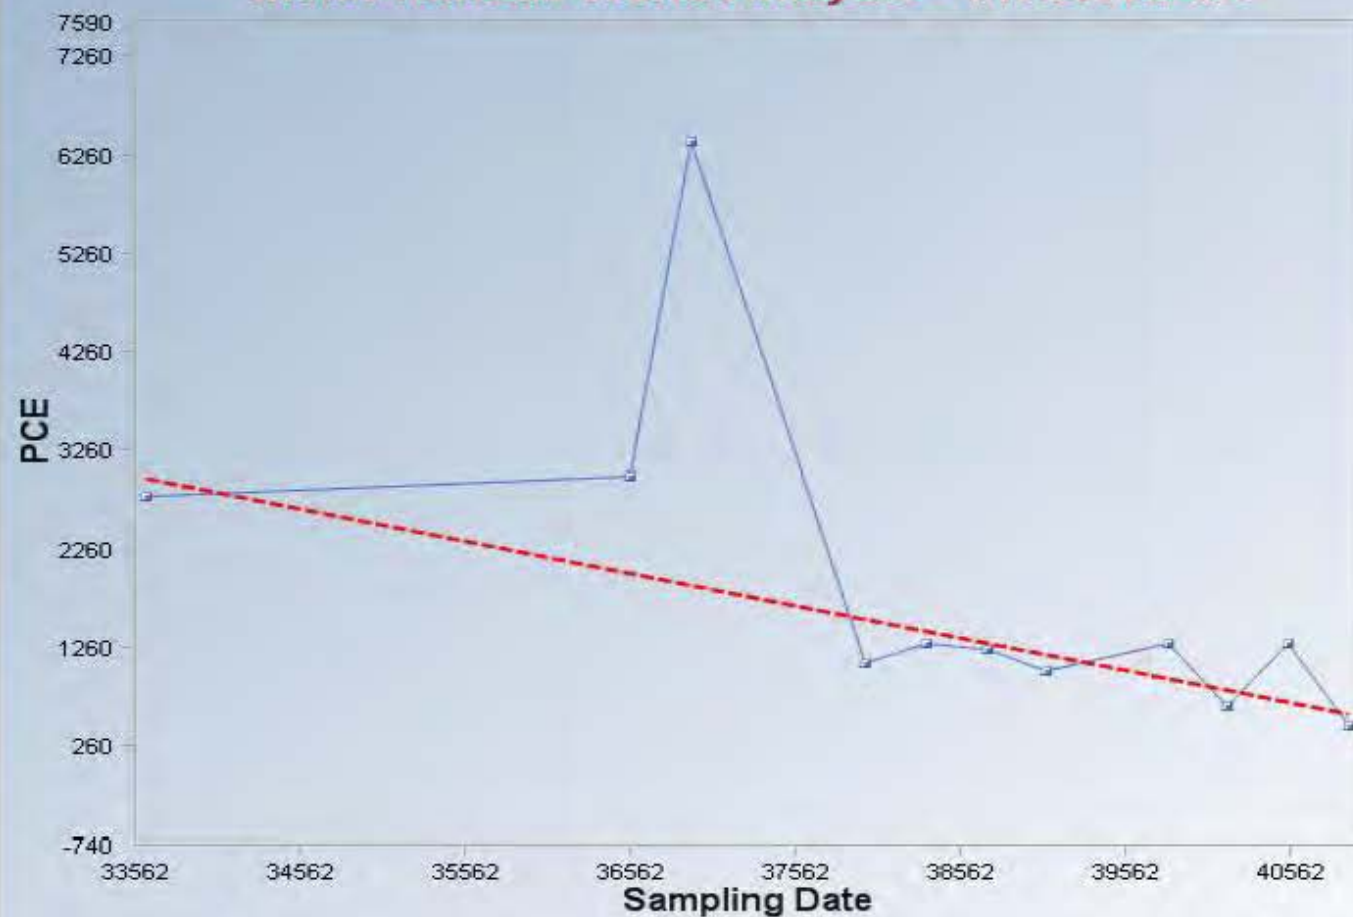
## Mann-Kendall Trend Analysis - 41755WL-02

### Mann-Kendall Trend Analysis

n	11.0000
Confidence Coefficient	0.9500
Level of Significance	0.0500
Test Value (S)	-28
Tabulated p-value	0.0130
Standard Deviation of S	12.7017
Standardized Value of S	-2.1257
Approximate p-value	0.0168

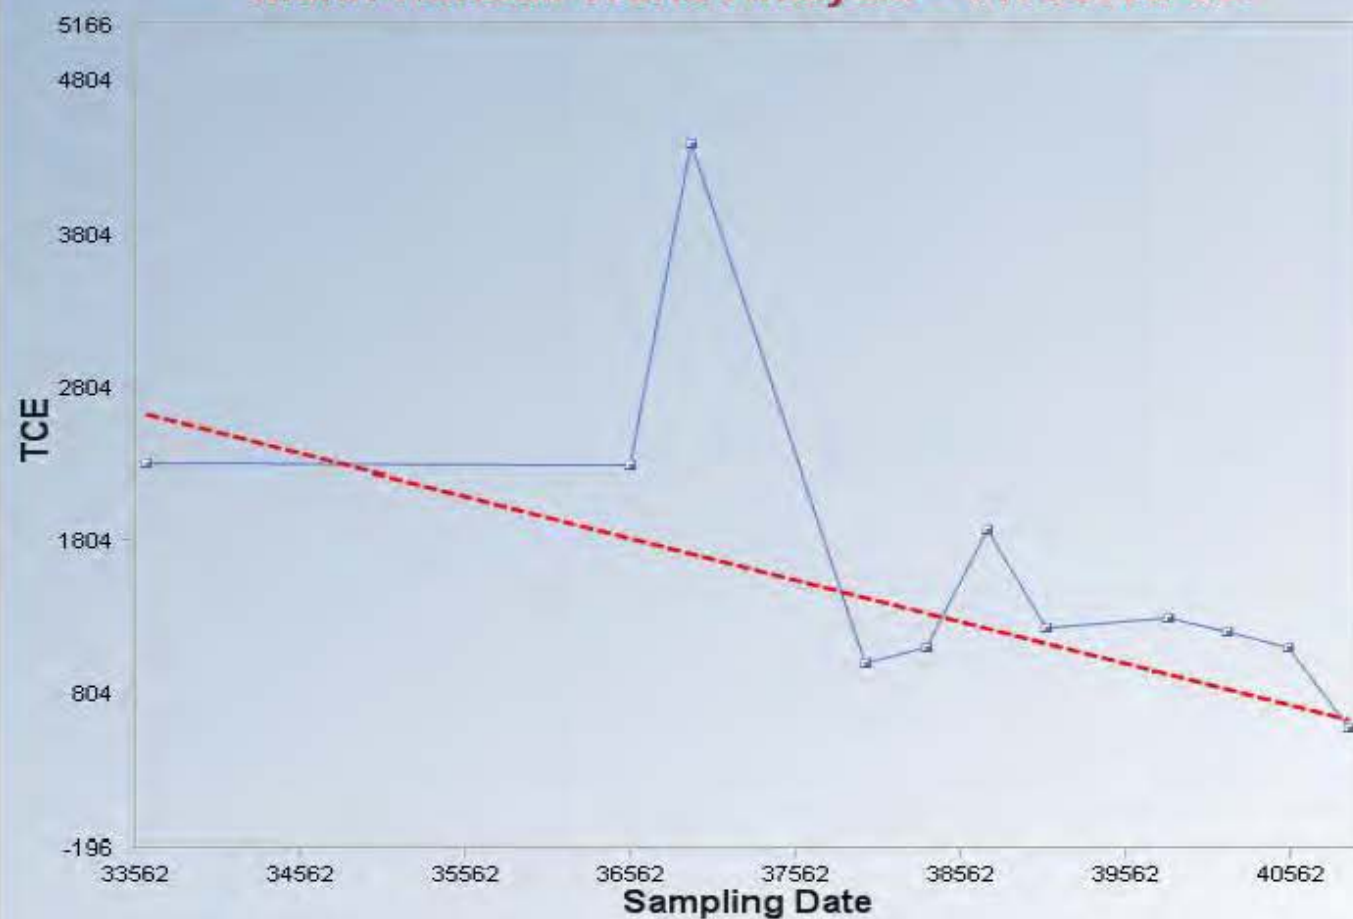
## Mann-Kendall Trend Analysis - 41755WL-02

### Mann-Kendall Trend Analysis

n	11.0000
Confidence Coefficient	0.9500
Level of Significance	0.0500
Test Value (S)	-28
Tabulated p-value	0.0130
Standard Deviation of S	12.8062
Standardized Value of S	-2.1083
Approximate p-value	0.0175

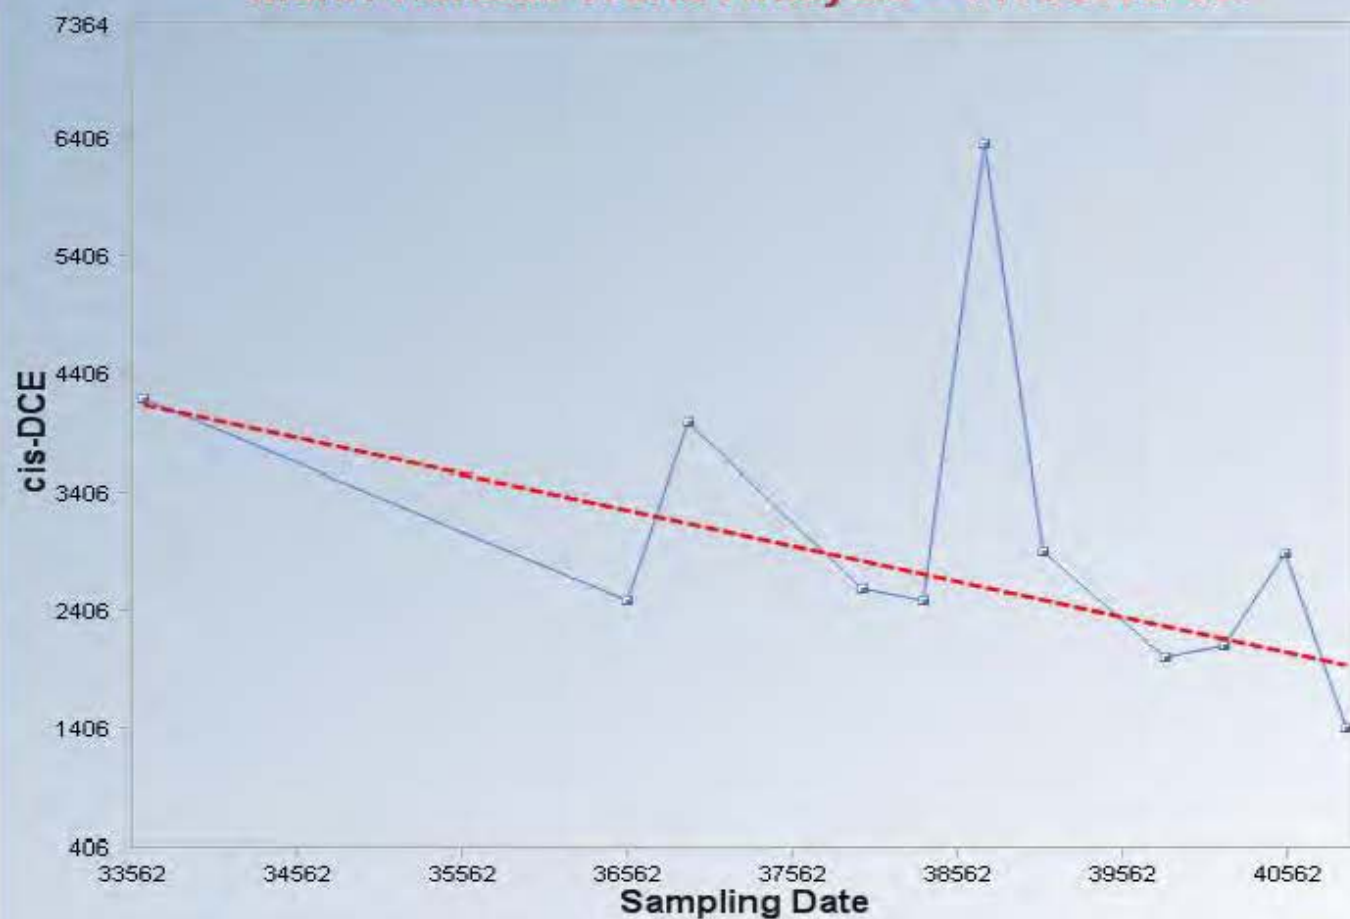
## Mann-Kendall Trend Analysis - 41755WL-02

### Mann-Kendall Trend Analysis

n	11.0000
Confidence Coefficient	0.9500
Level of Significance	0.0500
Test Value (S)	-21
Tabulated p-value	0.0600
Standard Deviation of S	12.8452
Standardized Value of S	-1.5570
Approximate p-value	0.0597
